POPPLETON HISTORIC STUDY

B-21155

226 N. Carrollton Avenue MAGI#042155560

Public School No. 15 (Junior High School No. 1031, Colored) 226 N. Carrollton Avenue

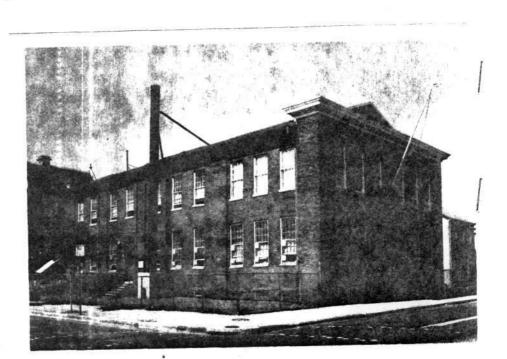
This may well be the old school building, to which various improvements have been added in the course of time. Standing adjacent to St. Luke's Clergy House and the nice building at 215 N. Carrollton, it and the space around it (now used for parking). reduce the density of the neighborhood and compose a pleasant grouping of buildings. Its 12/12 windows do not appear to be vandalized. The smoke stack should be painted white, or a bright color.

Environmental context: The relation to the Clergy House could be improved by planting a group of trees near Rankin Place, and the asphalt setback on Carrollton needs design and planting. If the use is to continue as administrative offices, a redesign of the grounds should take place forthwith, both east and west sides of the building.

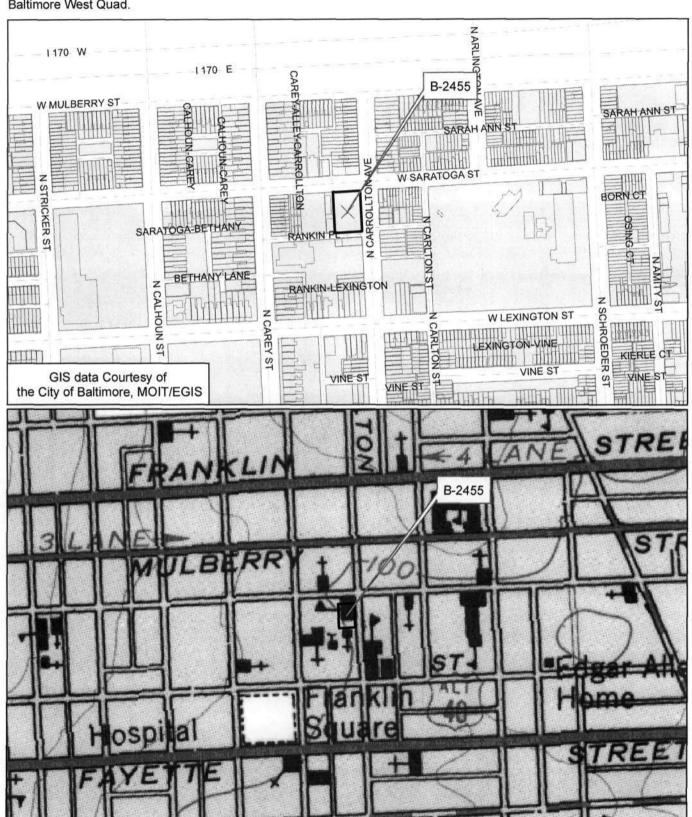
B-2455 226 N. Carrollton Avenue Block 0169 Lot 016 Baltimore City Baltimore West Quad.

Demolished
